Retrofitting and Strengthening Masonries of Heritage Structures: Materials Used

Ioanna Papayianni*

Laboratory of Building Materials, Department of Civil Engineering, Aristotle University of Thessaloniki, Thessaloniki, Greece

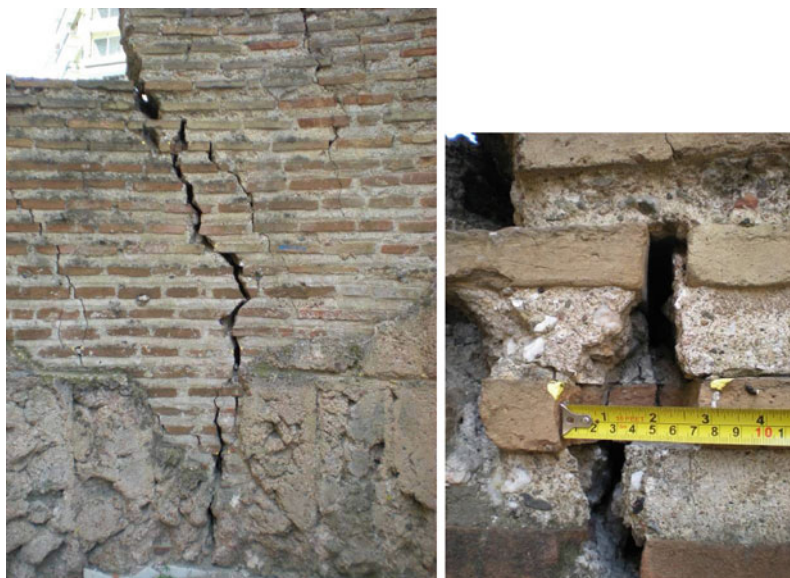
Fig. 2 Galerius palace ensemble, third century AD. Cracks filled with flowable lime-based mortar

A type of flowable mortar has been applied in filling cracks of a part of wall masonry in Galerius ensemble, by gravity or low pressure. The composition and mechanical characteristics are given in Table 4 and Fig. 2.

Table 4 Composition and strength of a flowable mortar applied in parts of Galerius ensemble

Raw materials	Parts by mass
Hydrated lime powder	1
Ground pozzolan	1
Limestone filler	0.7
Sand (0–4 mm)	6.5
Water/binder ratio	0.61
Superplasticizer (% by mass of binder)	2.4
Retarder (% by mass of binder)	0.3
Porosity	20.8 %
Flexural strength (specimens: 4 × 4 × 16 cm)	2.65 MPa
Compressive strength (specimens: 4 × 4 × 16 cm)	6.5 MPa

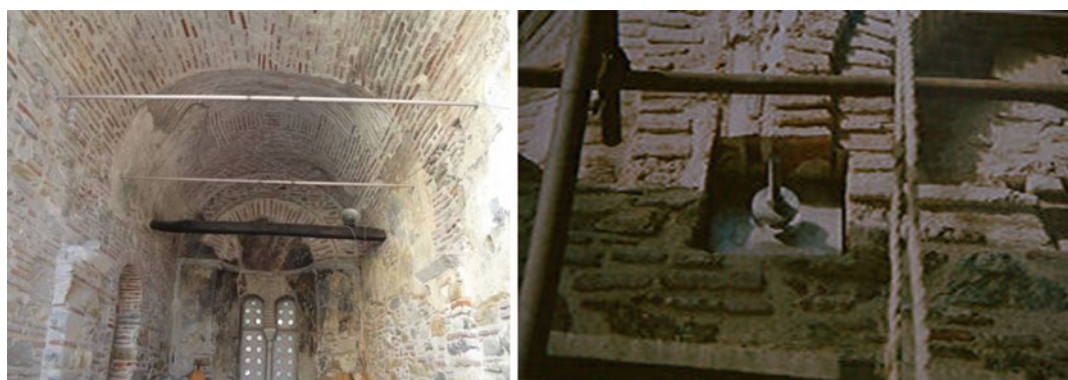
Fig. 3 St Panteleimon Church, Thessaloniki. Substitution of wooden tierods with stainless steel ones (Photograph courtesy of Prof. Ch. Ignatakis and Prof. K. Stylianidis)

- Pre-stressed (stainless) steel cables offered many solutions in the last decades of previous century (Fig. 3; Ignatakis and Stylianidis 1989).
- Stainless steel bars or strips into bed joints repointing with lime-based repair mortars. Bars or strips could also be made of carbon fiber reinforced polymer (CFRP) covered with lime-based mortars (Modena and Valluzzi 2003).
- Metallic braces anchored on the masonry for confinement of the out of plane failure deformations (Fig. 4; Ignatakis and Stylianidis 1989).
- Bonded to surface fiber reinforcement with polymer or cementitious matrices (FRP or FRG).

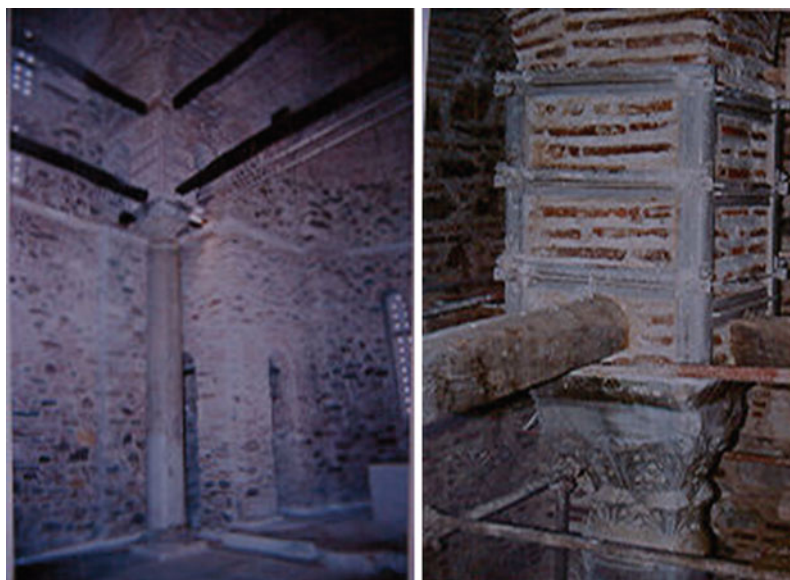
Fig. 4 St Panteleimon Church, Thessaloniki. Metallic braces for confinements of small part of pier above the column capital (Photograph courtesy of Prof. Ch. Ignatakis and Prof. K. Stylianidis)

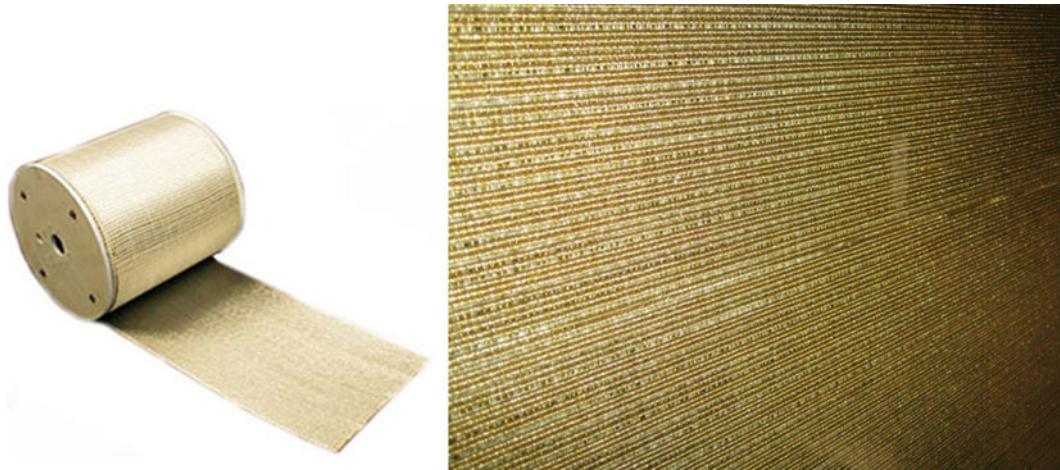
Fig. 5 Commercial steel and carbon fiber polymer sheets (Photograph courtesy of G. Mitolidis)

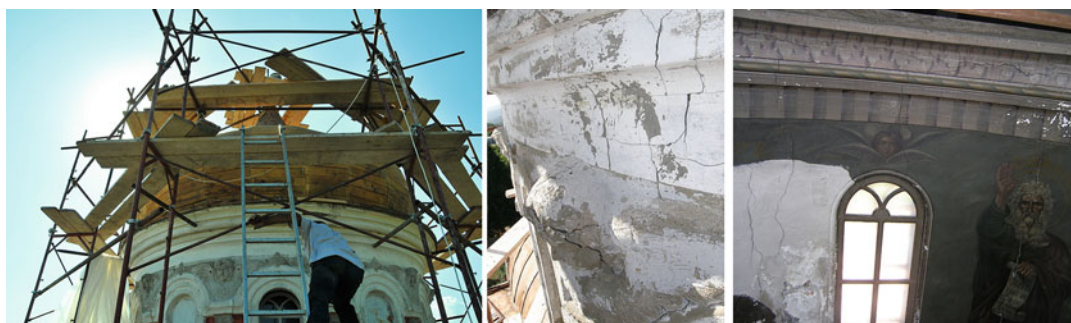
Fig. 6 The damages of the dome of the monastery at Andreas in Mount Athos before repair intervention (Photograph courtesy of G. Mitolidis)

Some outstanding examples of MHS strengthening with FRP mentioned in literature, such as the strengthening of the San Vitale Church in Parma, Italy, and the repair of the monastery of St Andreas, Mount Athos, 2011 (Figs. 6 and 7).

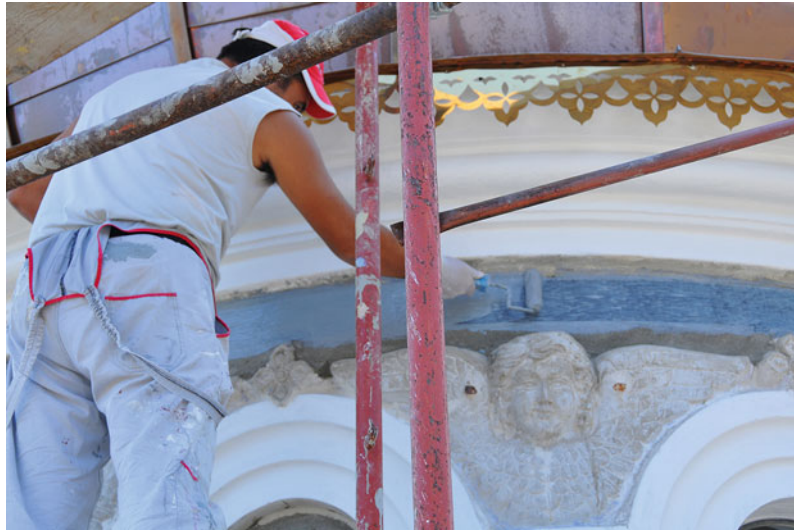
Fig. 7 The use of CFRP for strengthening the base of the dome of St Andreas in Mount Athos, 2011 (Photograph courtesy of G. Mitolidis)
